# **COMPARISON OF ACTUAL BUILDING DAMAGE AND REPAIR COSTS FROM THE PEPCON EXPLOSION TO INHABITED BUILDING DISTANCE EXPECTATIONS**

**JACK W. REED, JWR, Inc.  
5301 Central NE, Suite 220  
Albuquerque, New Mexico 87108  
and  
WILLIAM H. ZEHRT, JR., P. E.  
U. S. Army Engineering and Support Center, Huntsville  
P. O. Box 1600  
Huntsville, Alabama 35807**

## **ABSTRACT**

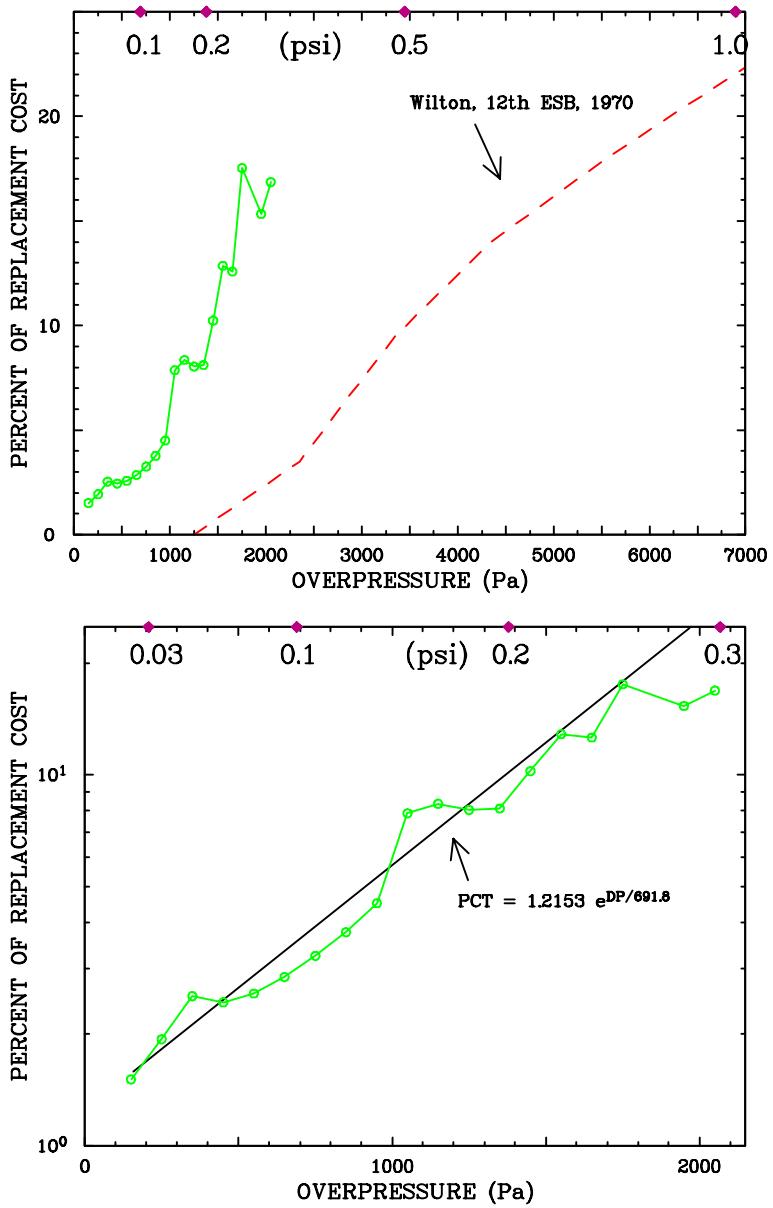
Figure 9. Total SFR damage percent of replacement cost  
 Top. Linear Cost Scale      Bottom. Exponential Cost Scale

Total claims damages were divided by CCC property improvement values, considering their 33% assessment ratio, to obtain the percent of replacement cost caused by the PEPCON

explosion. Show versus overpressure in Figure 9(a), cost ratios were significantly greater than previous values<sup>[10]</sup> obtained from structures built near large explosion tests. Several factors are involved. Much boom town construction around Las Vegas has been weak and shoddy; claims included cleaning as well as repairs to carpeting, curtains, bric-a-brac; claims adjustor's investigations were cursory at best versus detailed evaluations of test houses; and repair costs were inflated by this disaster's magnitude in a limited community.

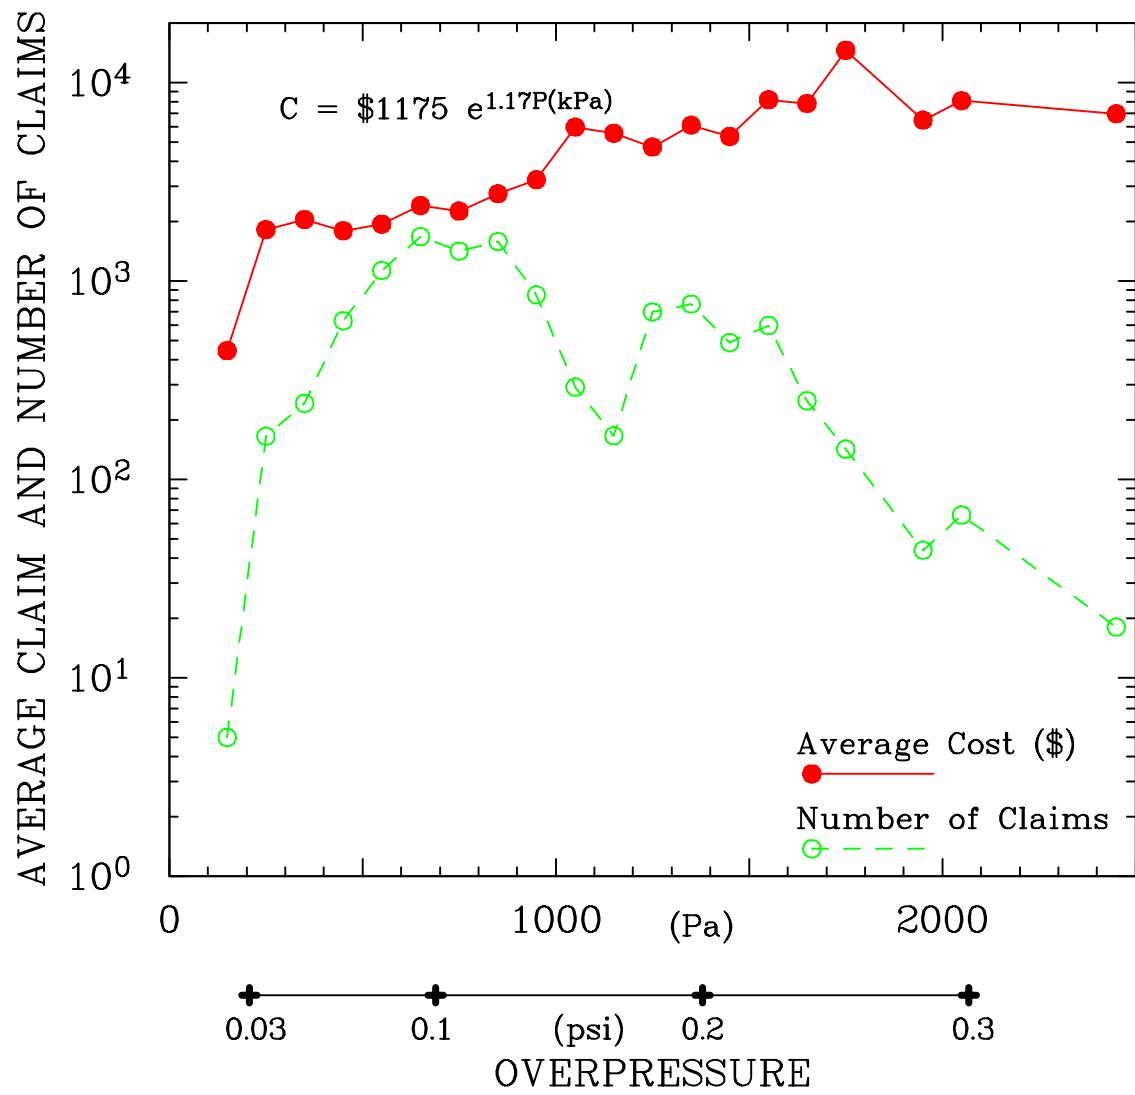
Figure 13. Total SFR damage claims versus overpressure; points for 100 Pa increments.

SFR damage claims, numbers and average dollar amounts are shown in Figure 13 versus overpressure. The dip in numbers between 800 Pa (0.12 psi) and 1300 Pa (0.19 psi) resulted from chance; several parks, golf courses, and undeveloped areas fell in that zone. Average claim costs increased regularly and exponentially with overpressure. Window damages, in Figure 14 showed an average around \$250 up to 900 Pa (0.13 psi), representing single pane repairs, then a general increase with overpressure as more panes were damaged per claim. Figure 15 shows percentages of SFRs that did not submit damage claims versus overpressure. Again, data generally follow the GDM trend, with the majority of SFRs making claims exposed to more than 1 kPa (0.15 psi).

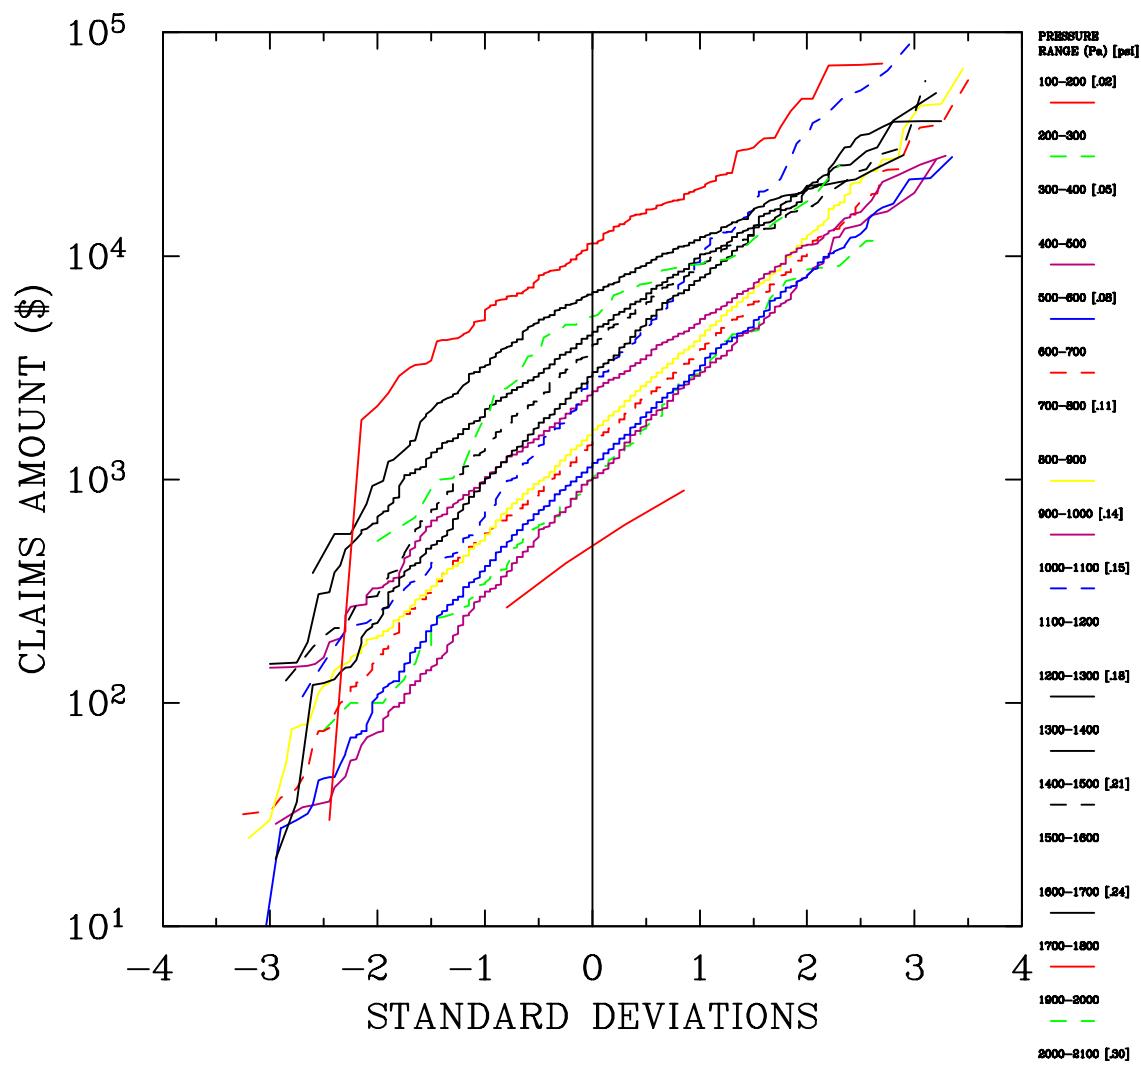
Figure 16. Distribution of SFR total claims amounts.

Statistical distributions of total claim amounts are shown in Figure 16, with separate curves for each 100 Pa (0.015 psi) overpressure increment. Overall, the lognormal distribution appears to fit these data with parameters varying with overpressure as shown in Figure 17. Scatter factors seemed to be generally constant, except for reduced scatter on the high side in approaching 2 kPa (0.29 psi) overpressure. This should be expected as more panes were broken to improve their statistics.
